Limited Visual Dam Safety Inspection Summary Report

MA-142

Middle Field 14 Reservoir

May 2006

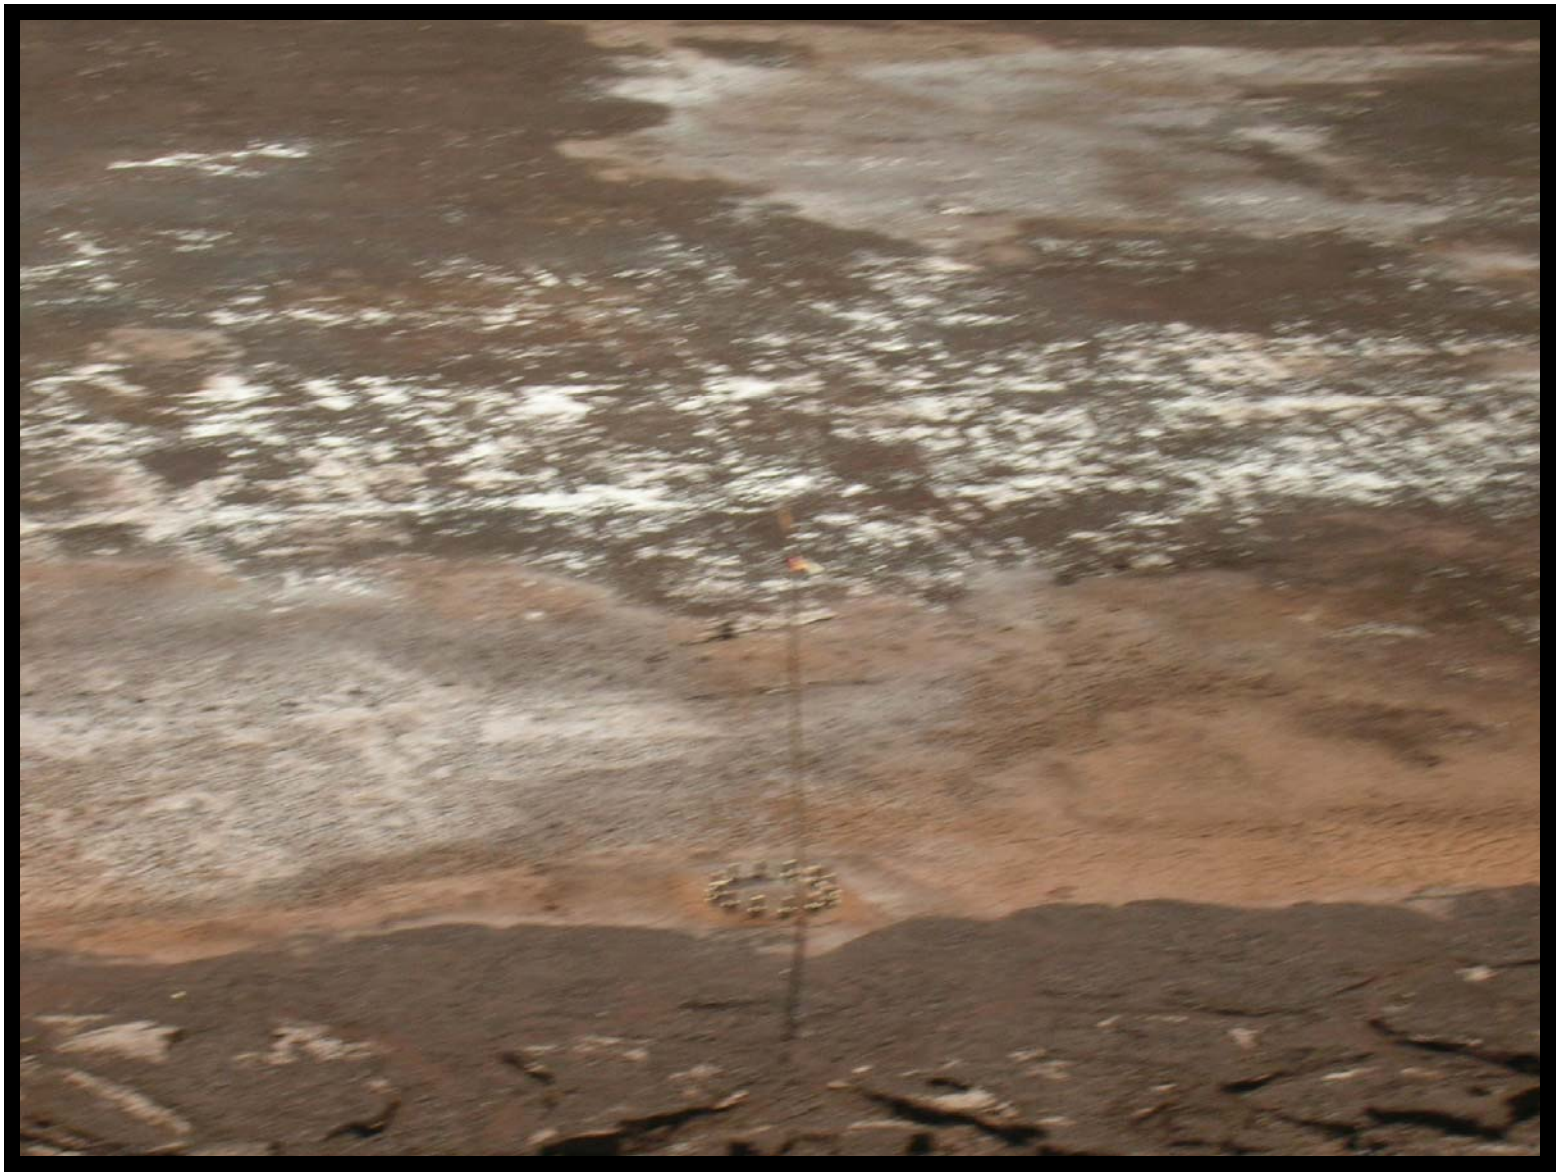
142 outlet intake

The outlet works appeared to be a 12" PVC pipe.
Not inspected in detail, not tested. The outlet works was controlled via a valve on the upstream side of the dam. Seepage was not observed flowing near the exit of the outlet works from the dam.

a. The outlet works were not tested.
b. The outlet works appeared to be in satisfactory condition, no corrective actions are required at this time.

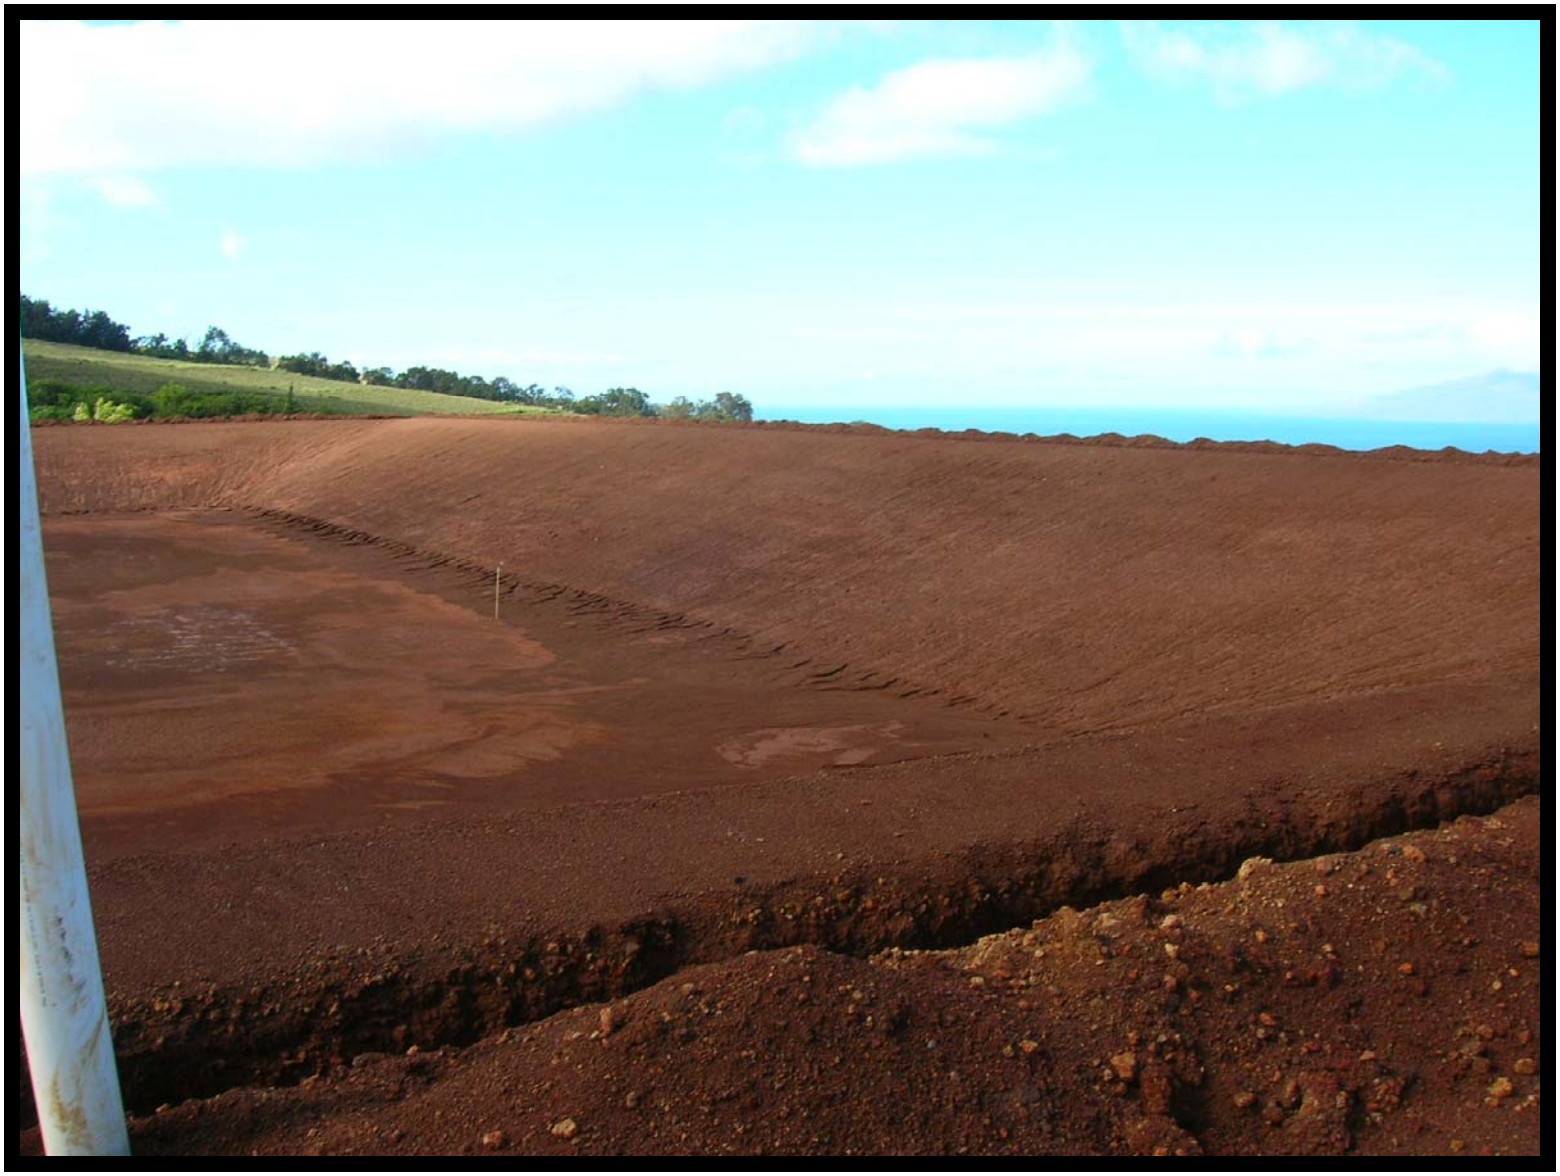
142 upstream slope

E. Upstream Slope: (Satisfactory)
The upstream slope is 1 on 3.
A HDPE liner is being constructed. Erosion, cracks and sinkholes were not observed.

Findings and Corrective Actions:
a. The upstream slope appeared to be in satisfactory condition, no corrective actions are required at this time.
