Dam ID: HI00002 Puu Lua Reservoir	Vulnerability Index: Extreme 1, High 2, Moderate 3, Low 4	Inspection No: _____ Date: 22 Mar 2006

STATE OF HAWAII - DLNR
VISUAL DAM SAFETY INSPECTION SHEET

Inspection Type: Visual Dam Safety Inspection

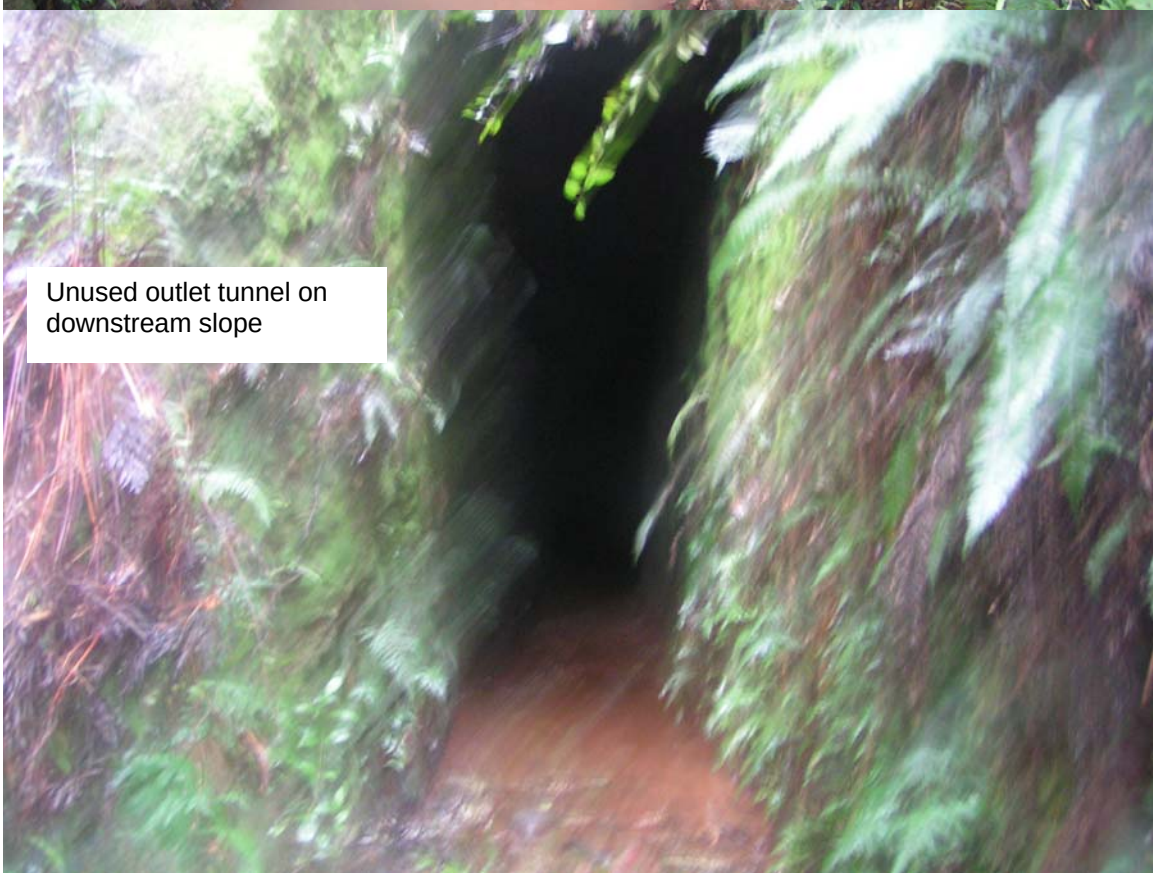
x Flowing, Description: Clear – 20 gpm – left/above unused outlet

X j. There is no access to the unused tunnel exit on D/S slope.

Unused outlet tunnel on downstream slope
